National Institute for Aviation Research

Kansas Aviation Research and Technology (KART)

Minimum Thickness of Aluminum Skins in Lightning Direct Attachment Zones

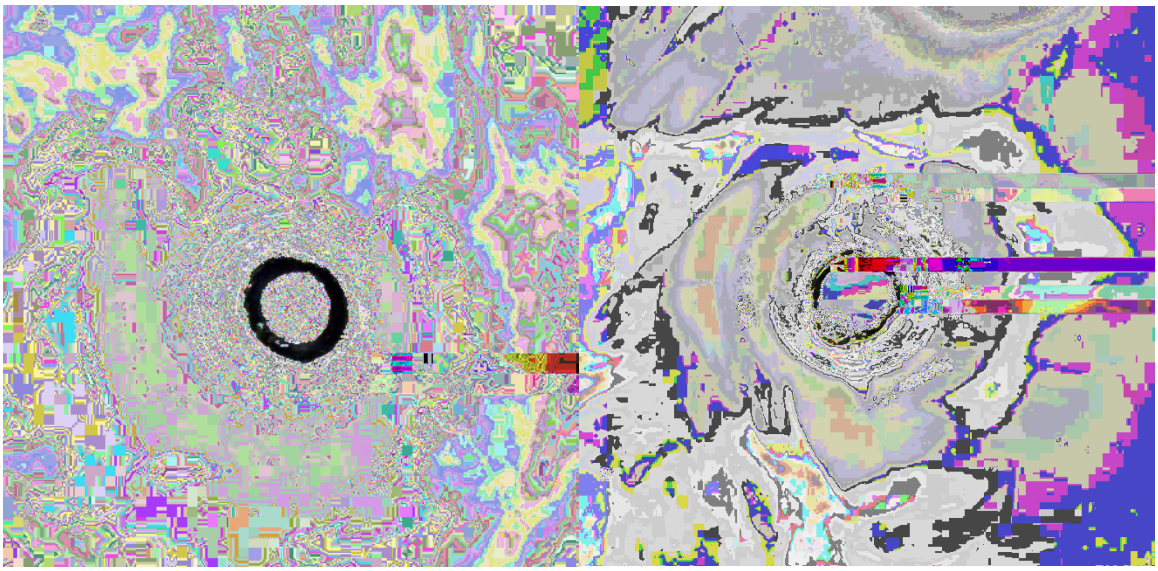
Figure 7: Left: Exterior-side damage, and right: through hole

After lightning testing, the panels were visually evaluated for melt-through damage and measurement of holes. Melt-through holes were categorized into two designations regarding the type of damage visible on the interior (fuel tank side) of the panel.

1. Panels with “damage” show evidence of melting on the interior side of the panel, but the damage area is intact and does not contain a through hole.
2. Panels with “through holes” are damaged areas in which daylight can be seen all the way through the panel.

Examples of damage compared with through hole are shown in Figure 7 and Figure 8.
